# Walk Around

## Focke-Wulf Fw 190A/F

Walk Around Number 22  
squadron/signal publications

By Malcolm Laing and E. Brown Ryle

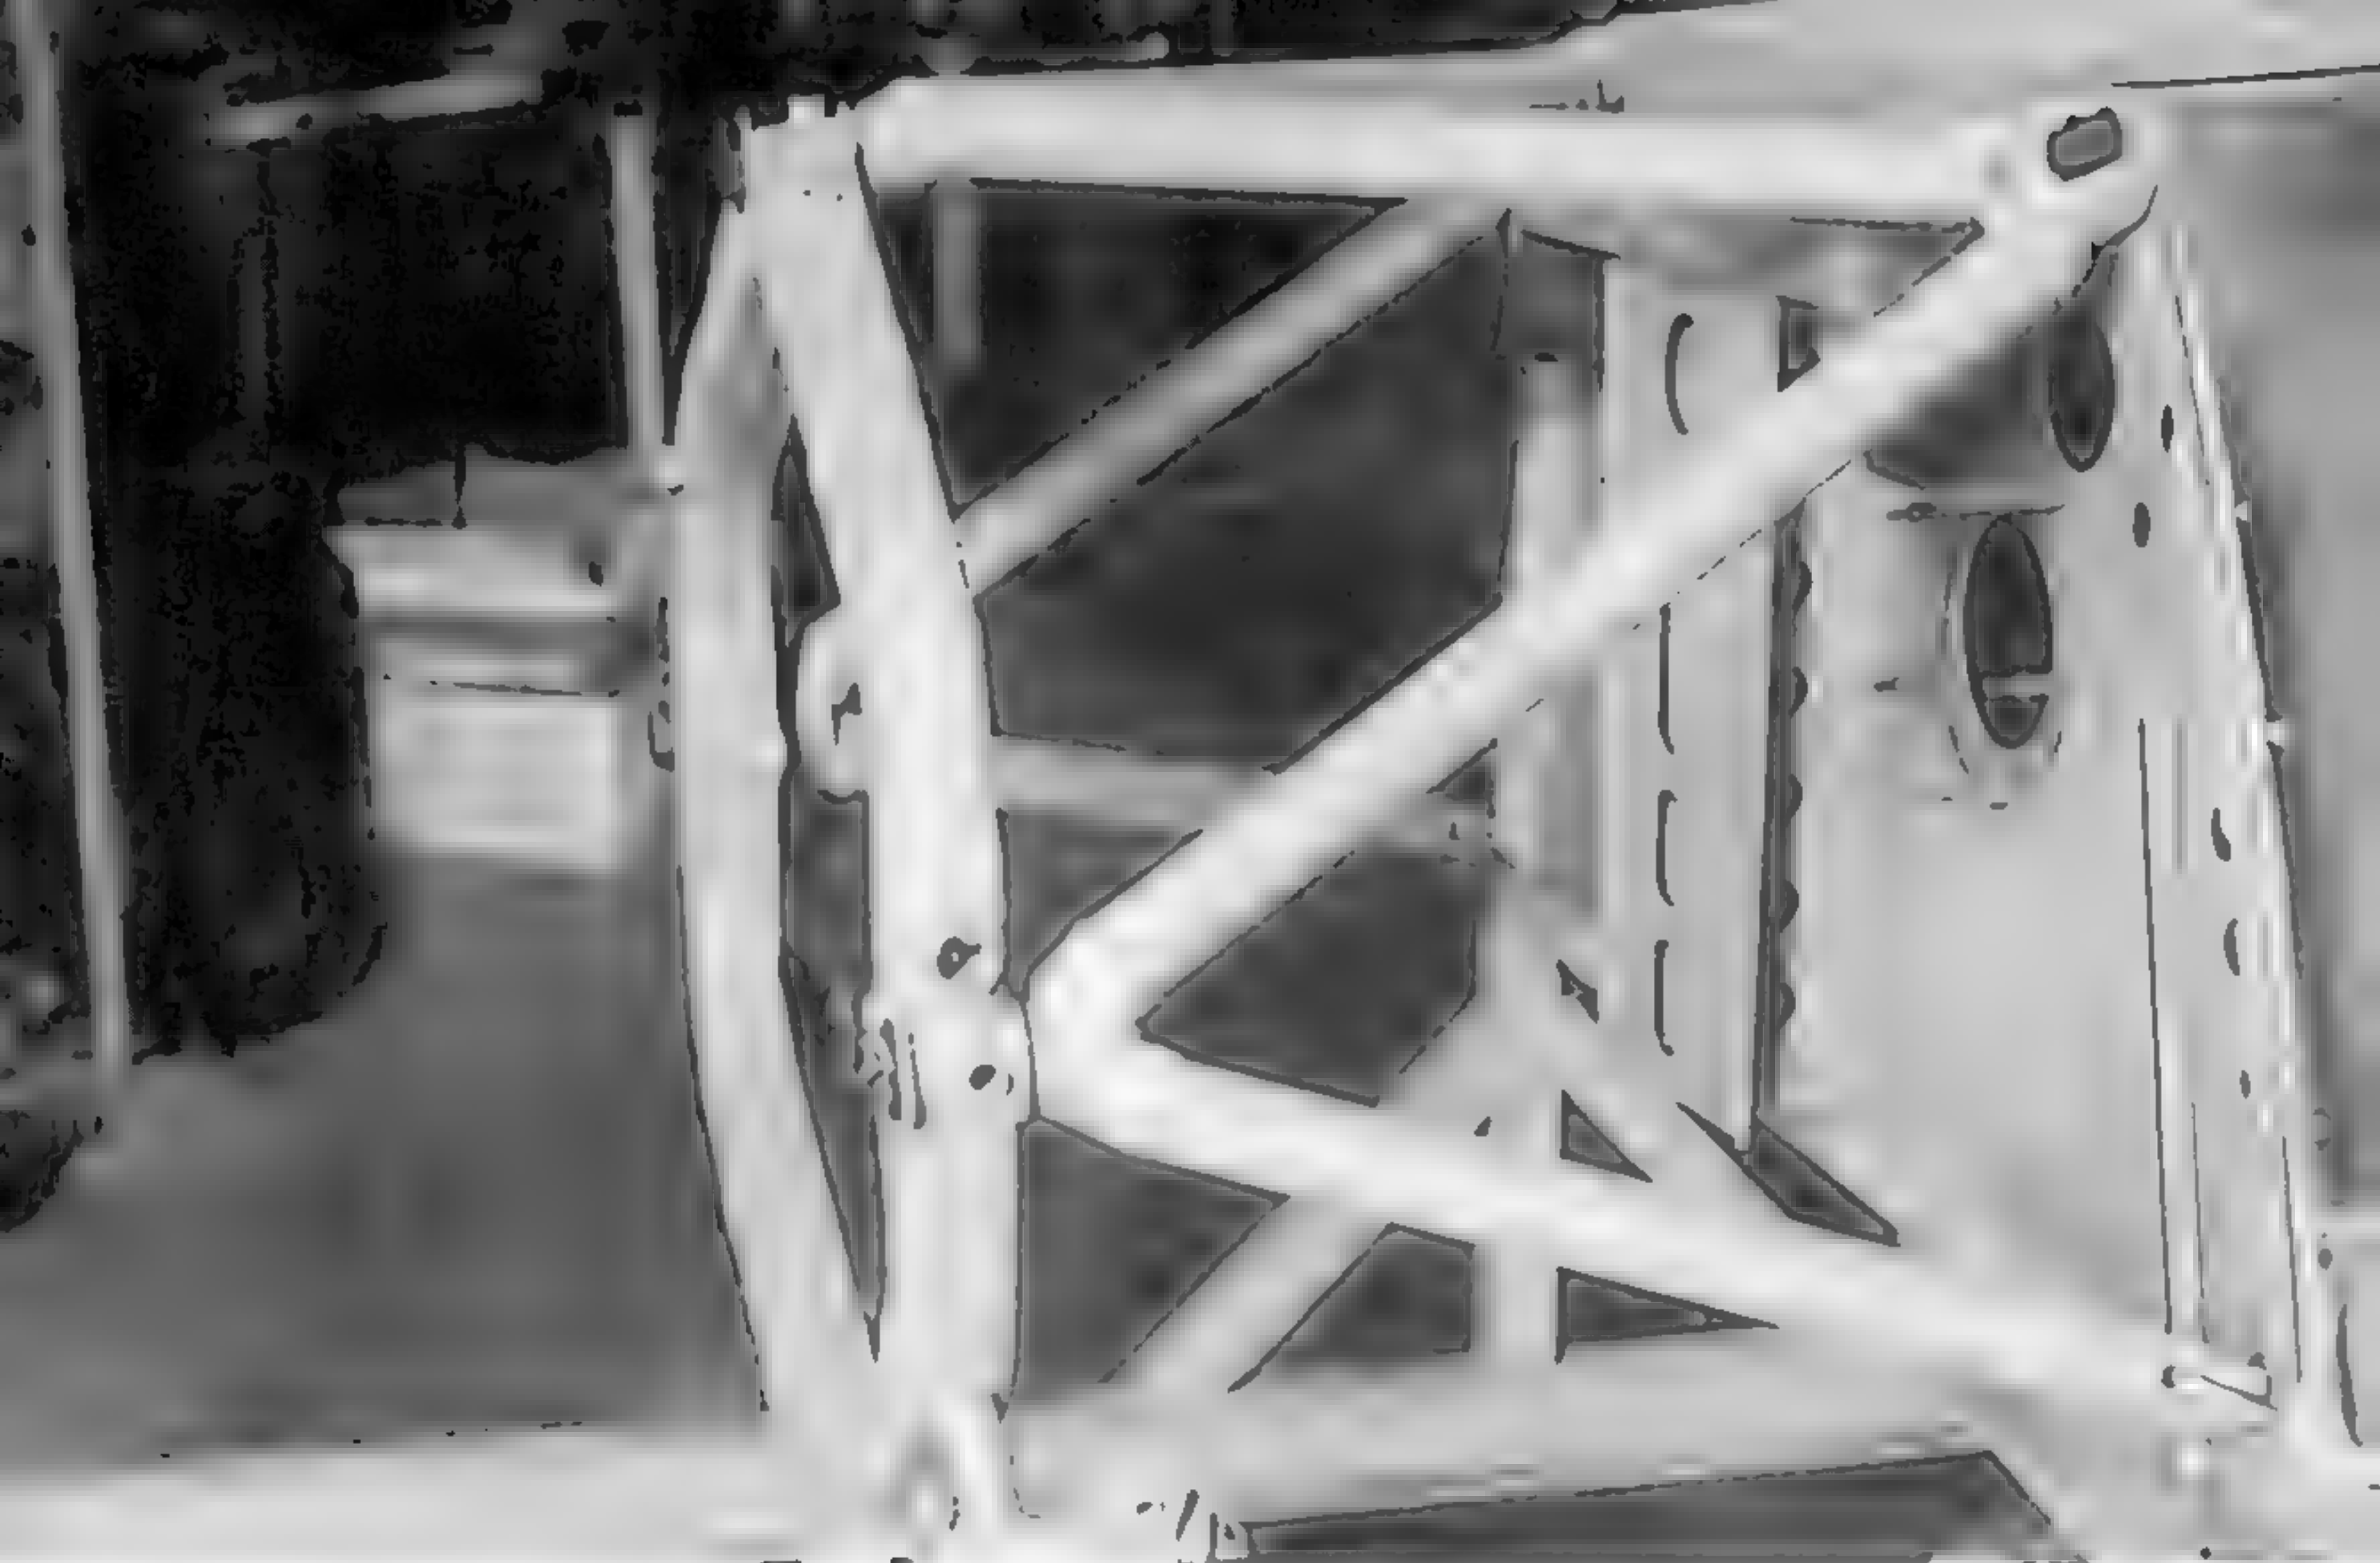
(Above Left) The Fw 190A's engine bearer assembly, which supported the engine mounting ring, is secured to the fuselage firewall. The hollow mounting ring was the oil reservoir for the engine control unit. Two sheet metal guide brackets for the cowl gun ammunition boxes are fitted on the outside of the firewall between the upper and lower bearing attachment points. (Laing)

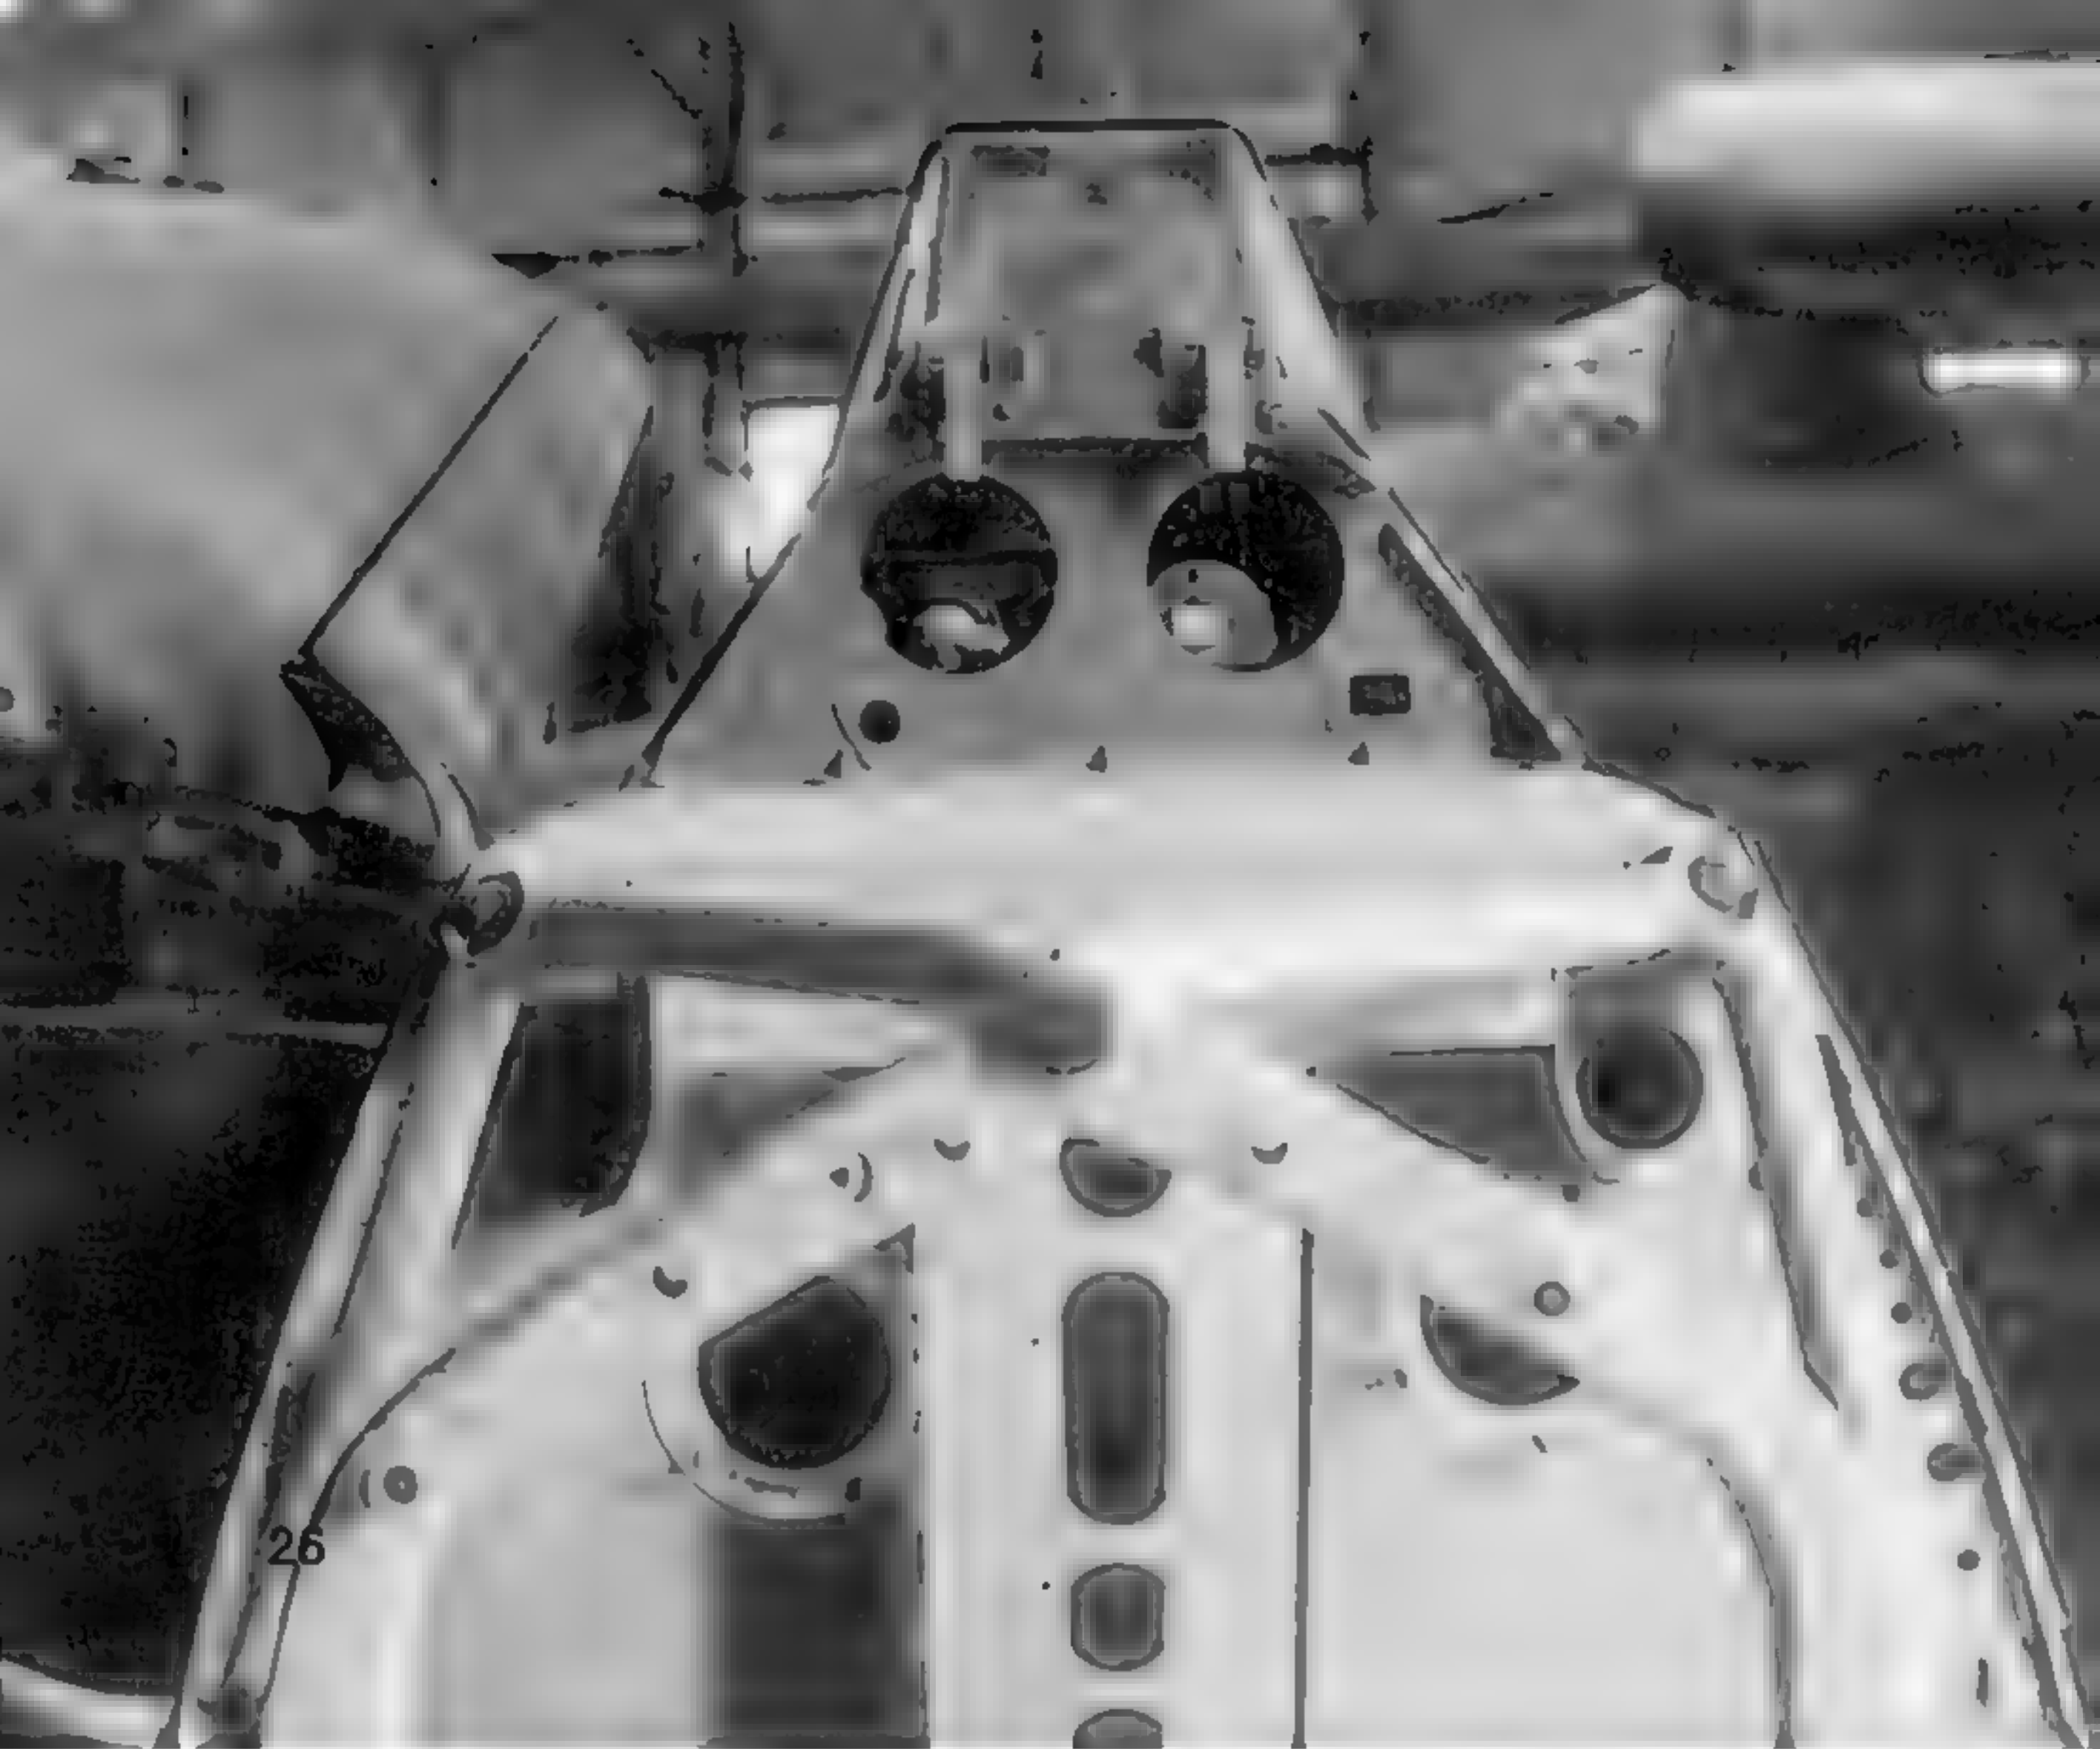
(Left) The engine mounting ring and bearer assembly has been installed on an Fw 190A-3 undergoing restoration at the Texas Air Museum in Rio Hondo. The upper engine bearer attachment points were located at the outer corners of the fuselage firewall. Inside guide brackets for the cowling gun ammunition boxes are placed on the firewall's center, flanked by holes for the brake master cylinder access panels. (Laing)

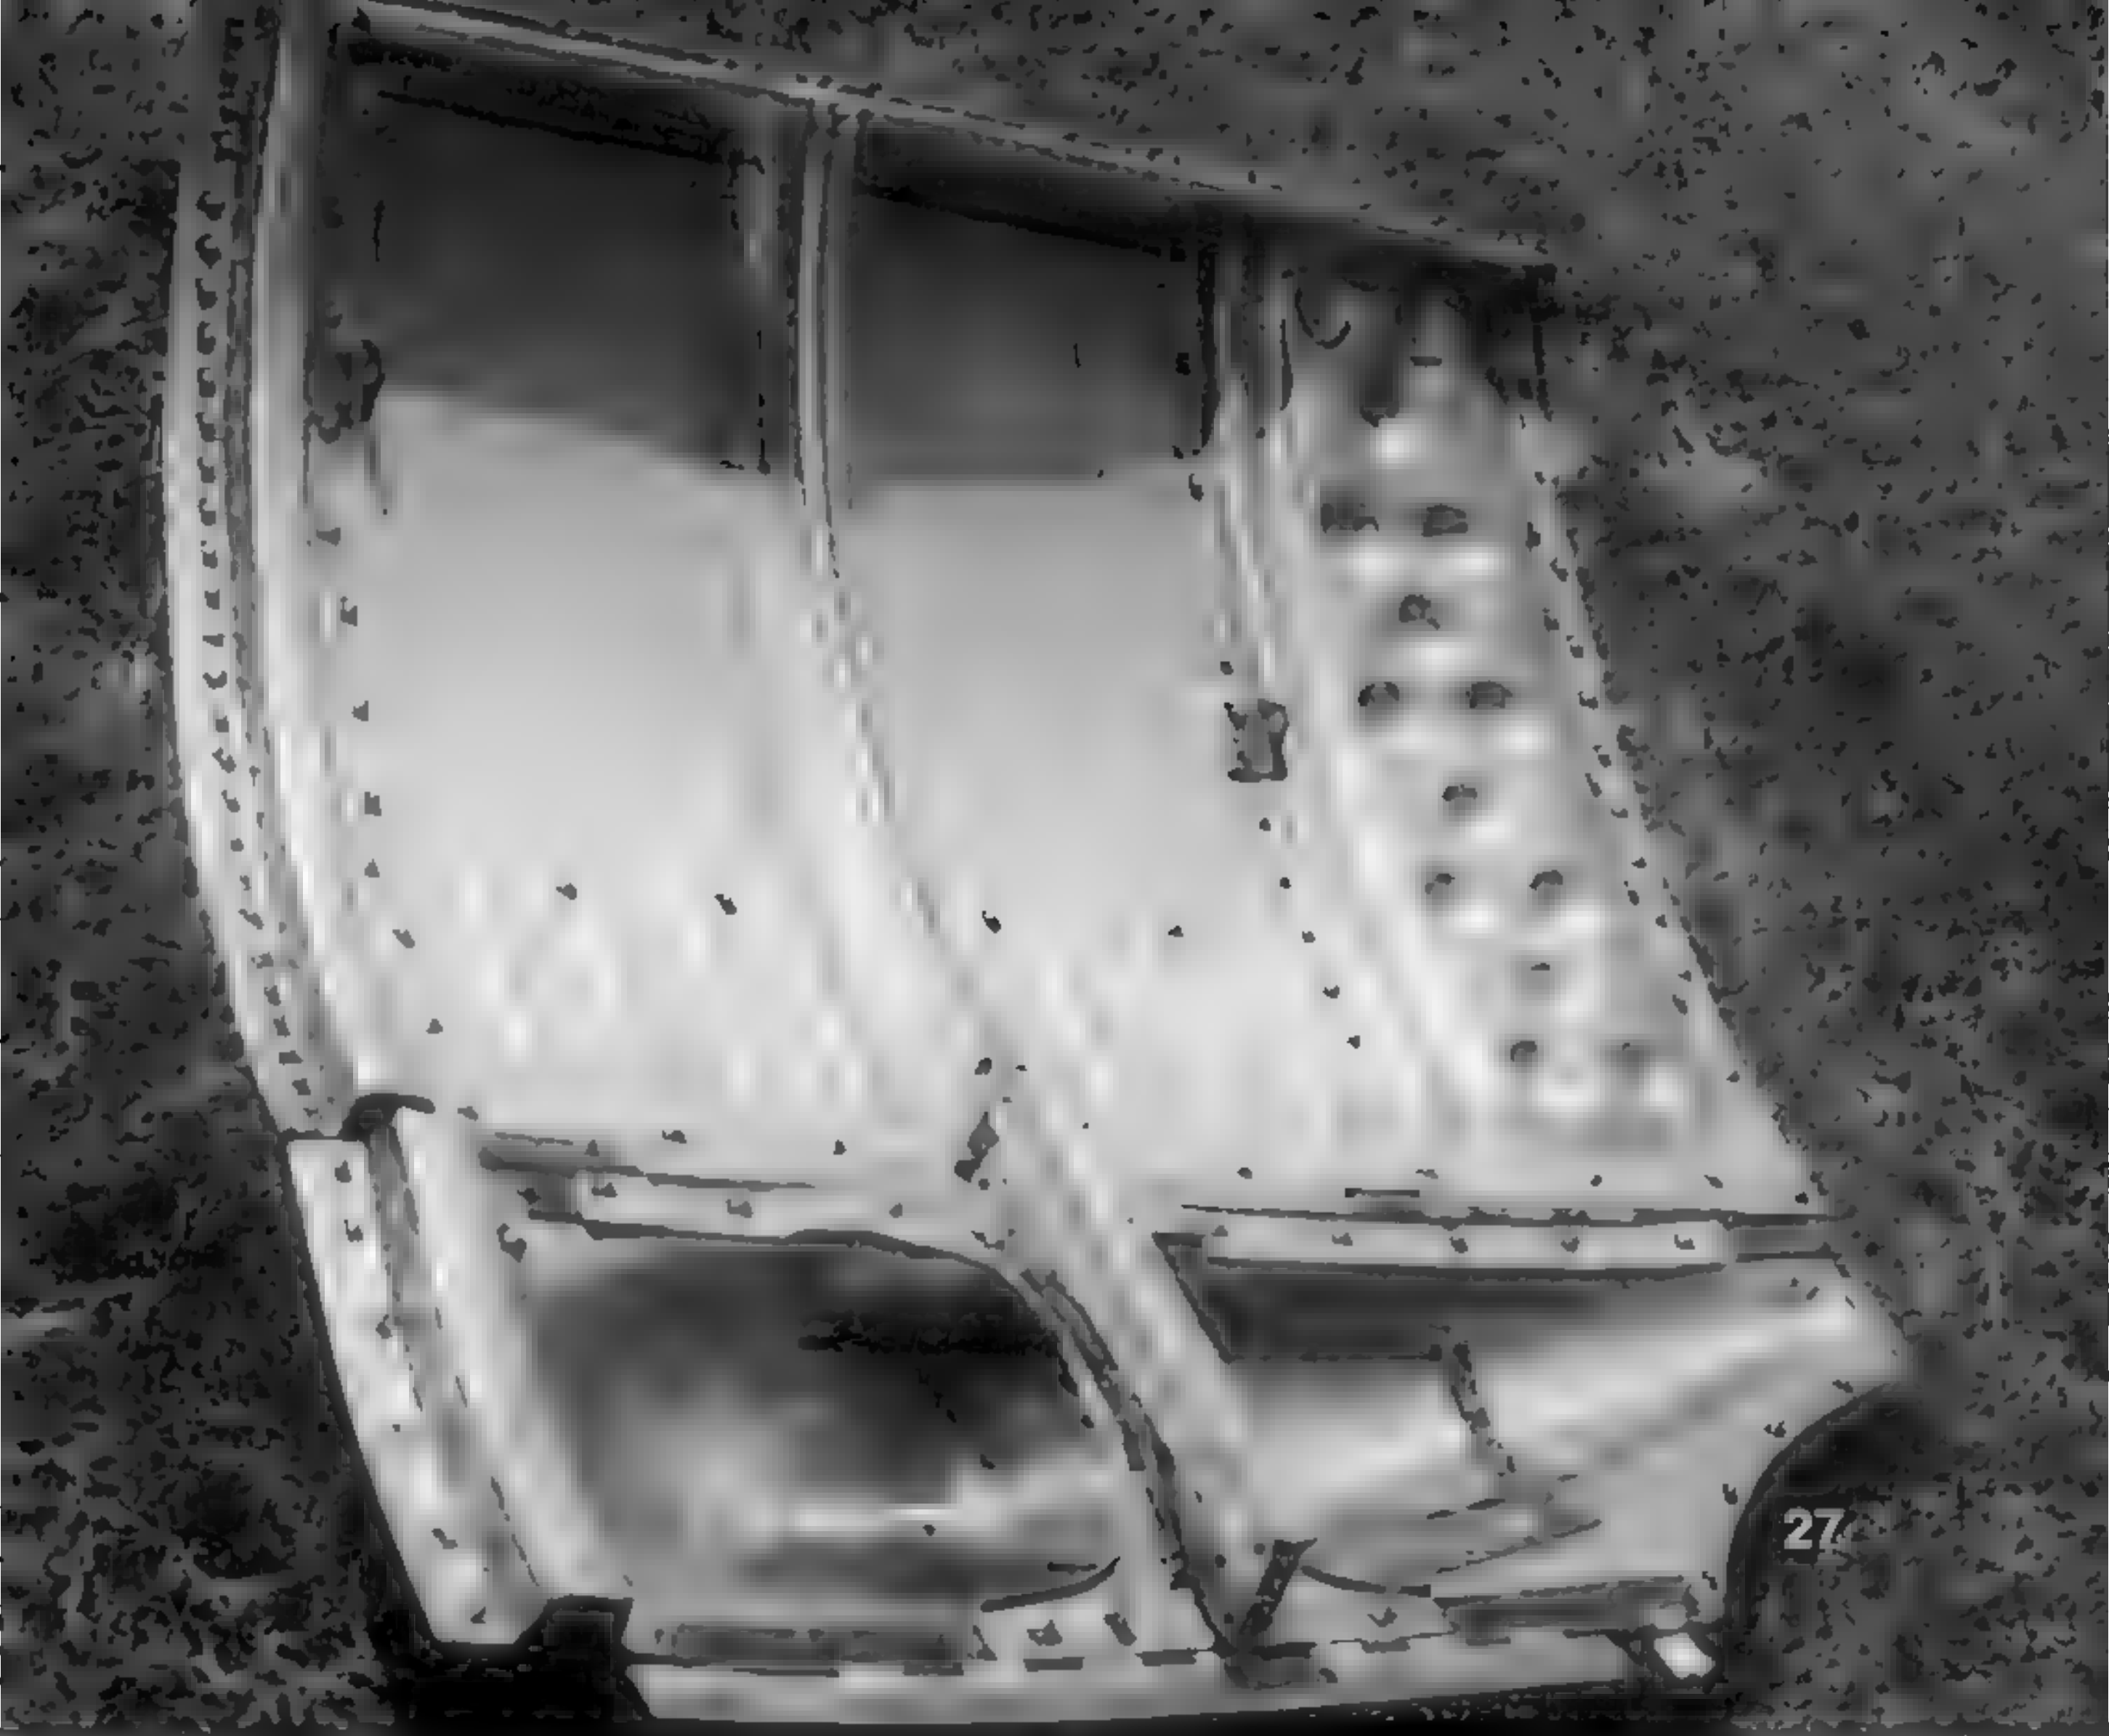
(Right) The inside of the starboard engine cowl of an Fw 190A being restored at Rio Hondo is natural metal – the original state of this surface when the part was recovered. The bulged area provided clearance for the engine air intake. A directional funnel will be placed at the bulge's aft (narrow) end when this part is fully restored for installation.

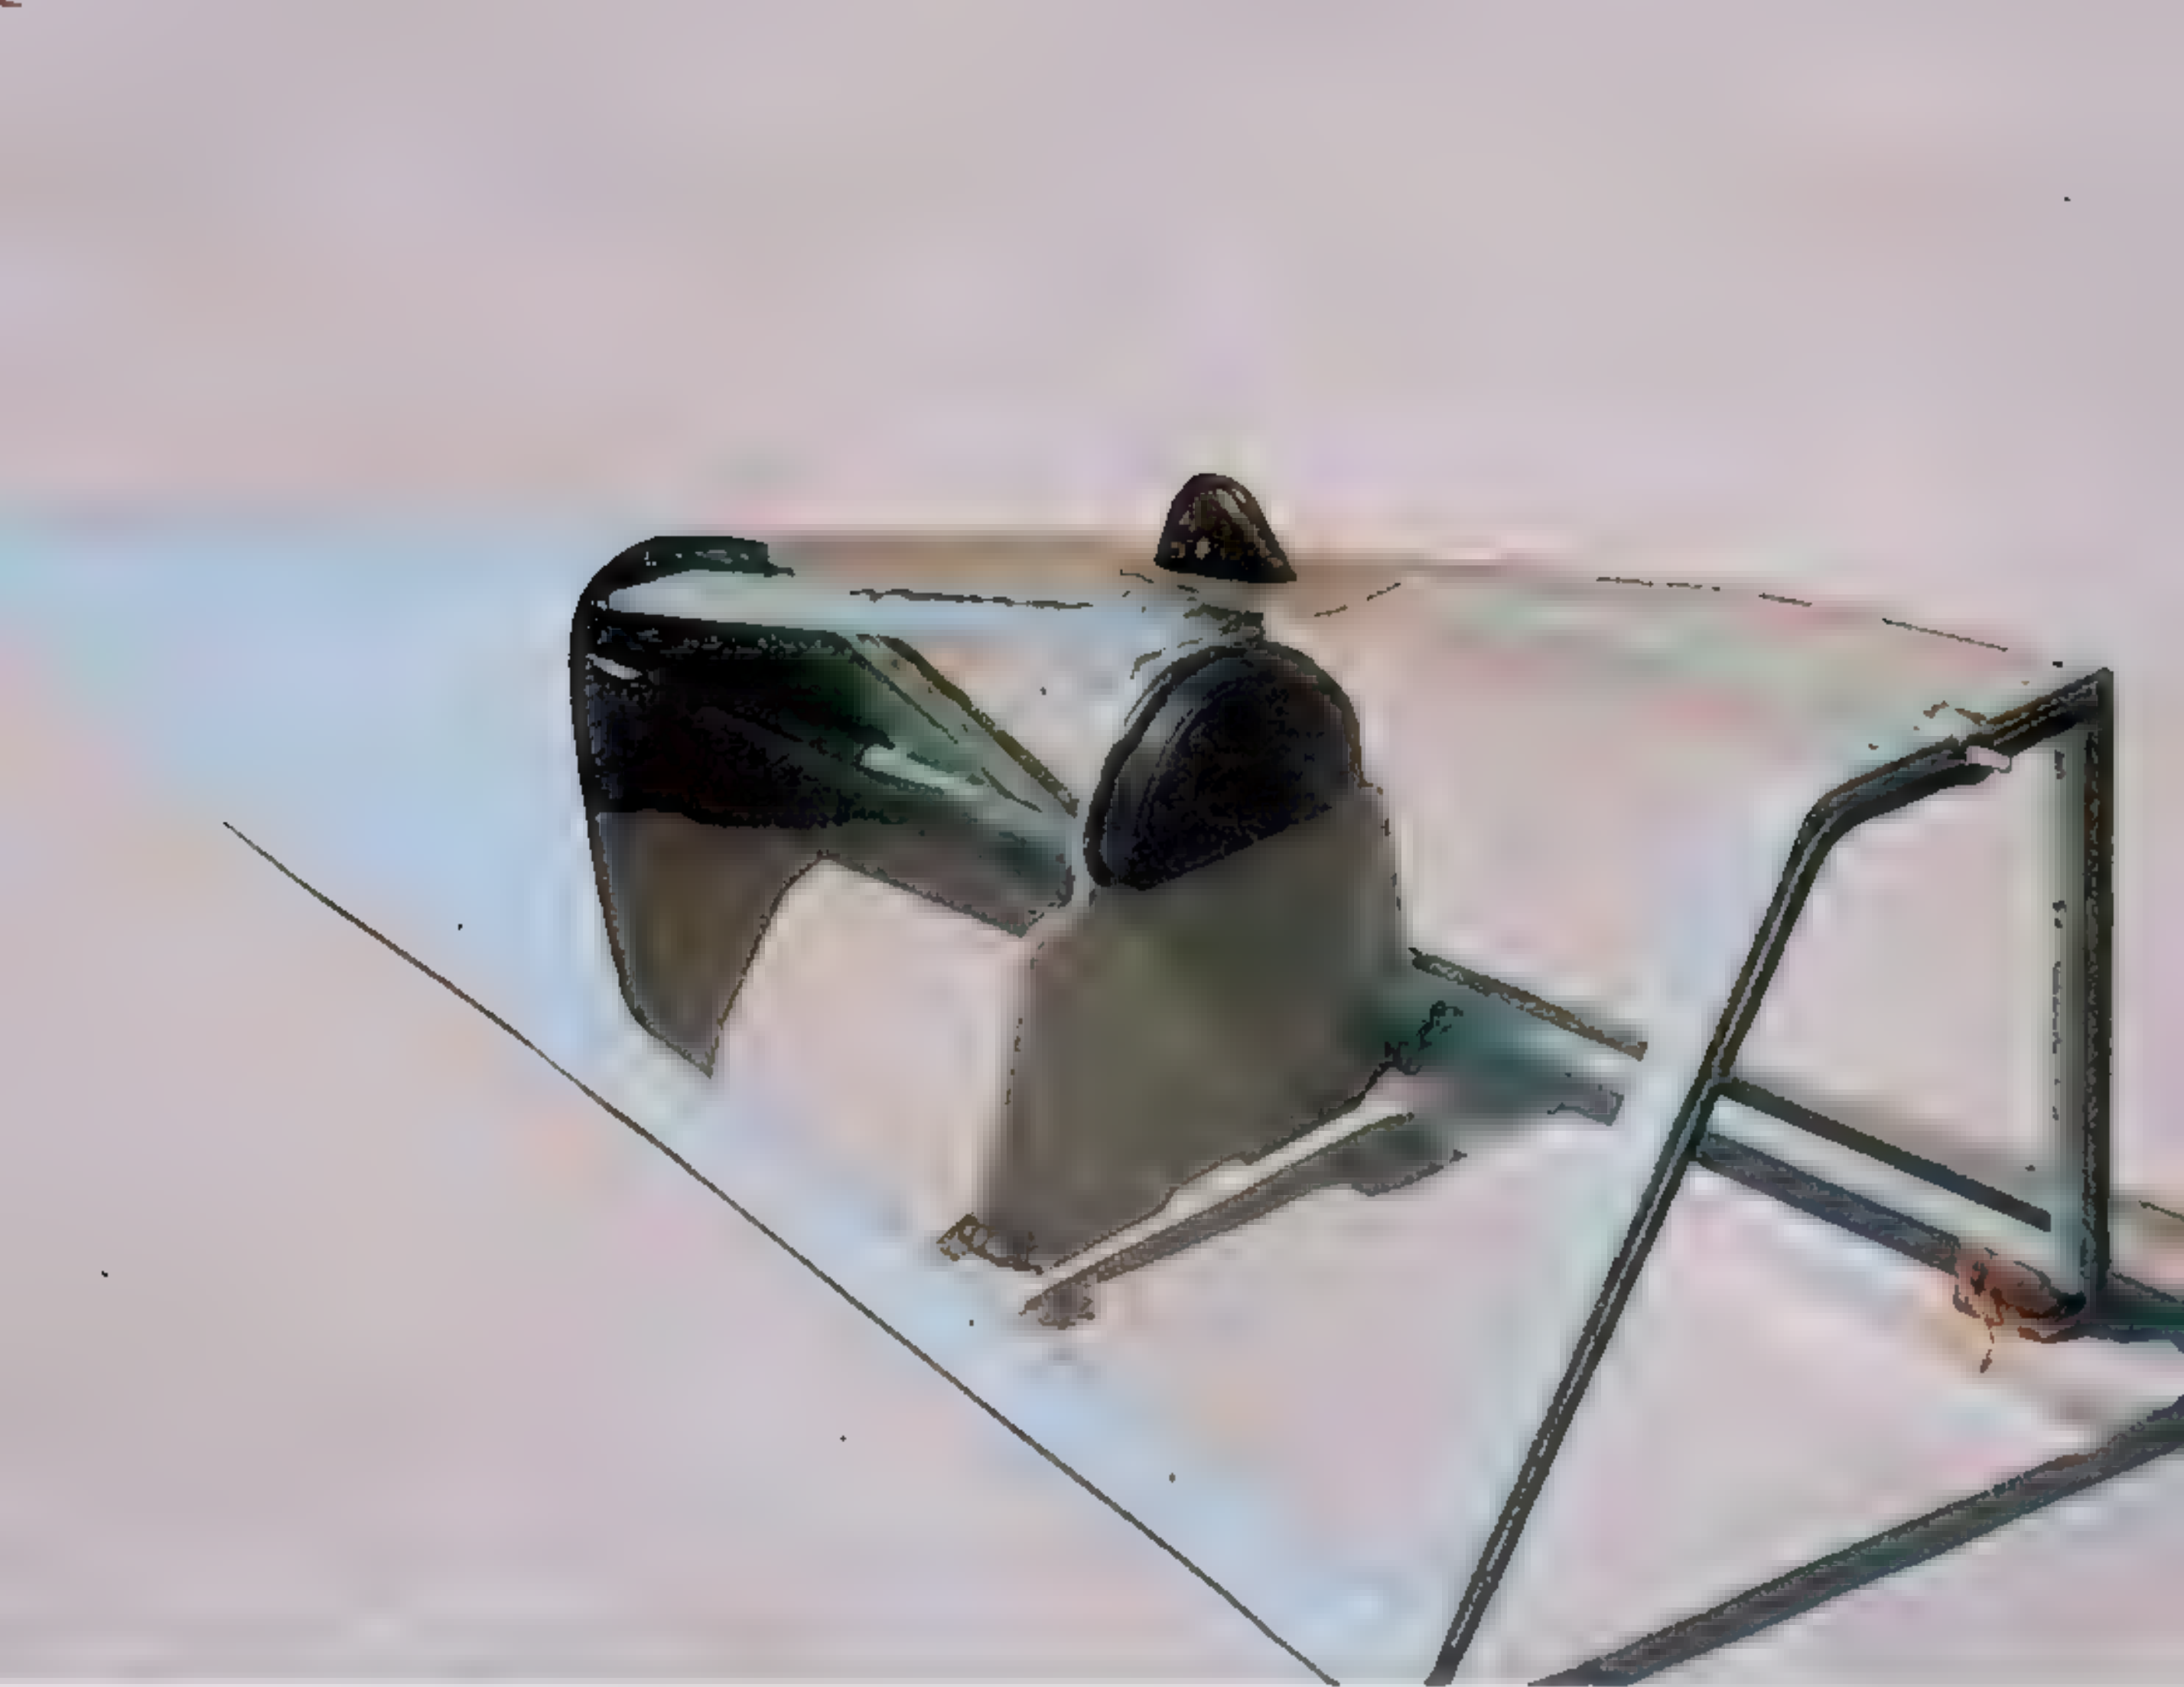
(Left) The canopy's leading edge included a rubber seal to ensure a tight fit with the armored windshield. The small metal spike at the top of the leading edge fit into a hole in the rear of the windshield. This spike helped provide alignment and a rigid fit between the two assemblies. The armored headrest was attached with pivoting mounts at the bottom to the canopy's internal tube bracing. These mounts allowed the headrest to move up and down when the canopy flexed while opening or closing. (Thinnes)

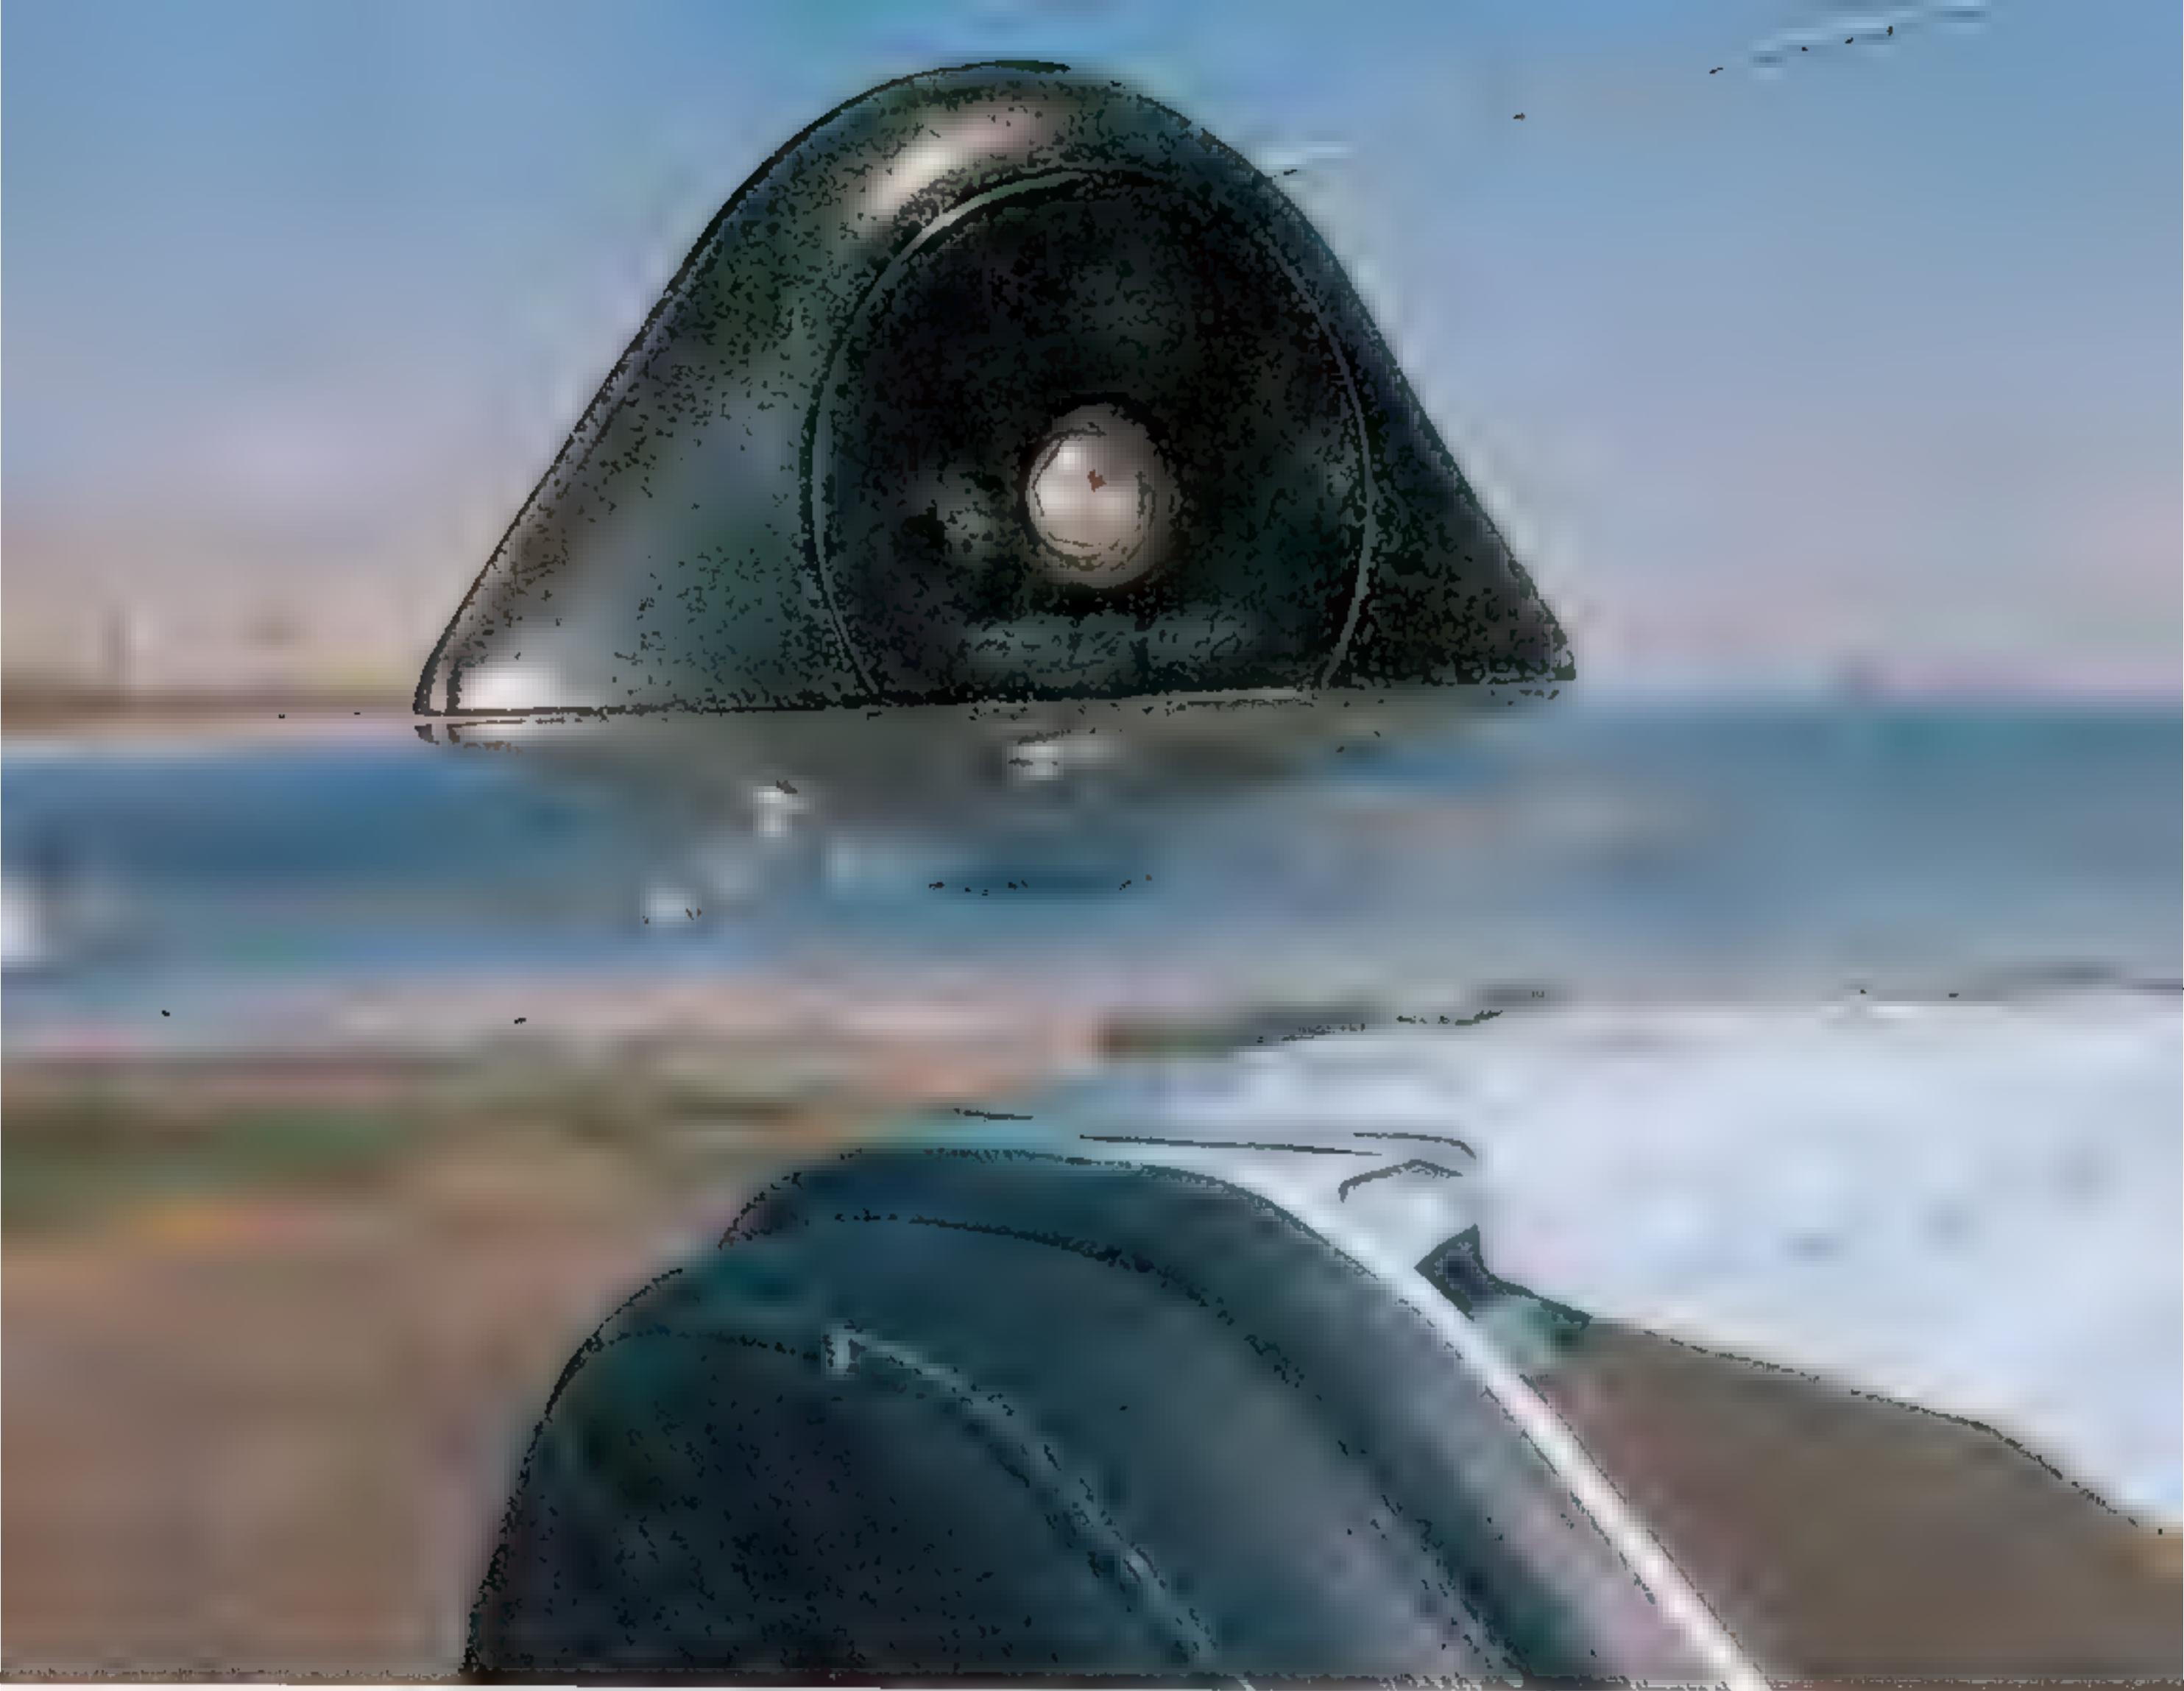
(Above) This restored external canopy antenna wire roller assembly is an original unit produced for the Fw 190A. This item held the main antenna wire in place at high airspeeds and high G (gravity) loads. This assembly features a plastic body with steel fittings and internal parts. The part number 0-190.121-0192 is imprinted on this device. (Thinnes)  
ernal parts. The part number 0-190.121-0192 is imprinted on this device. (Thinnes)

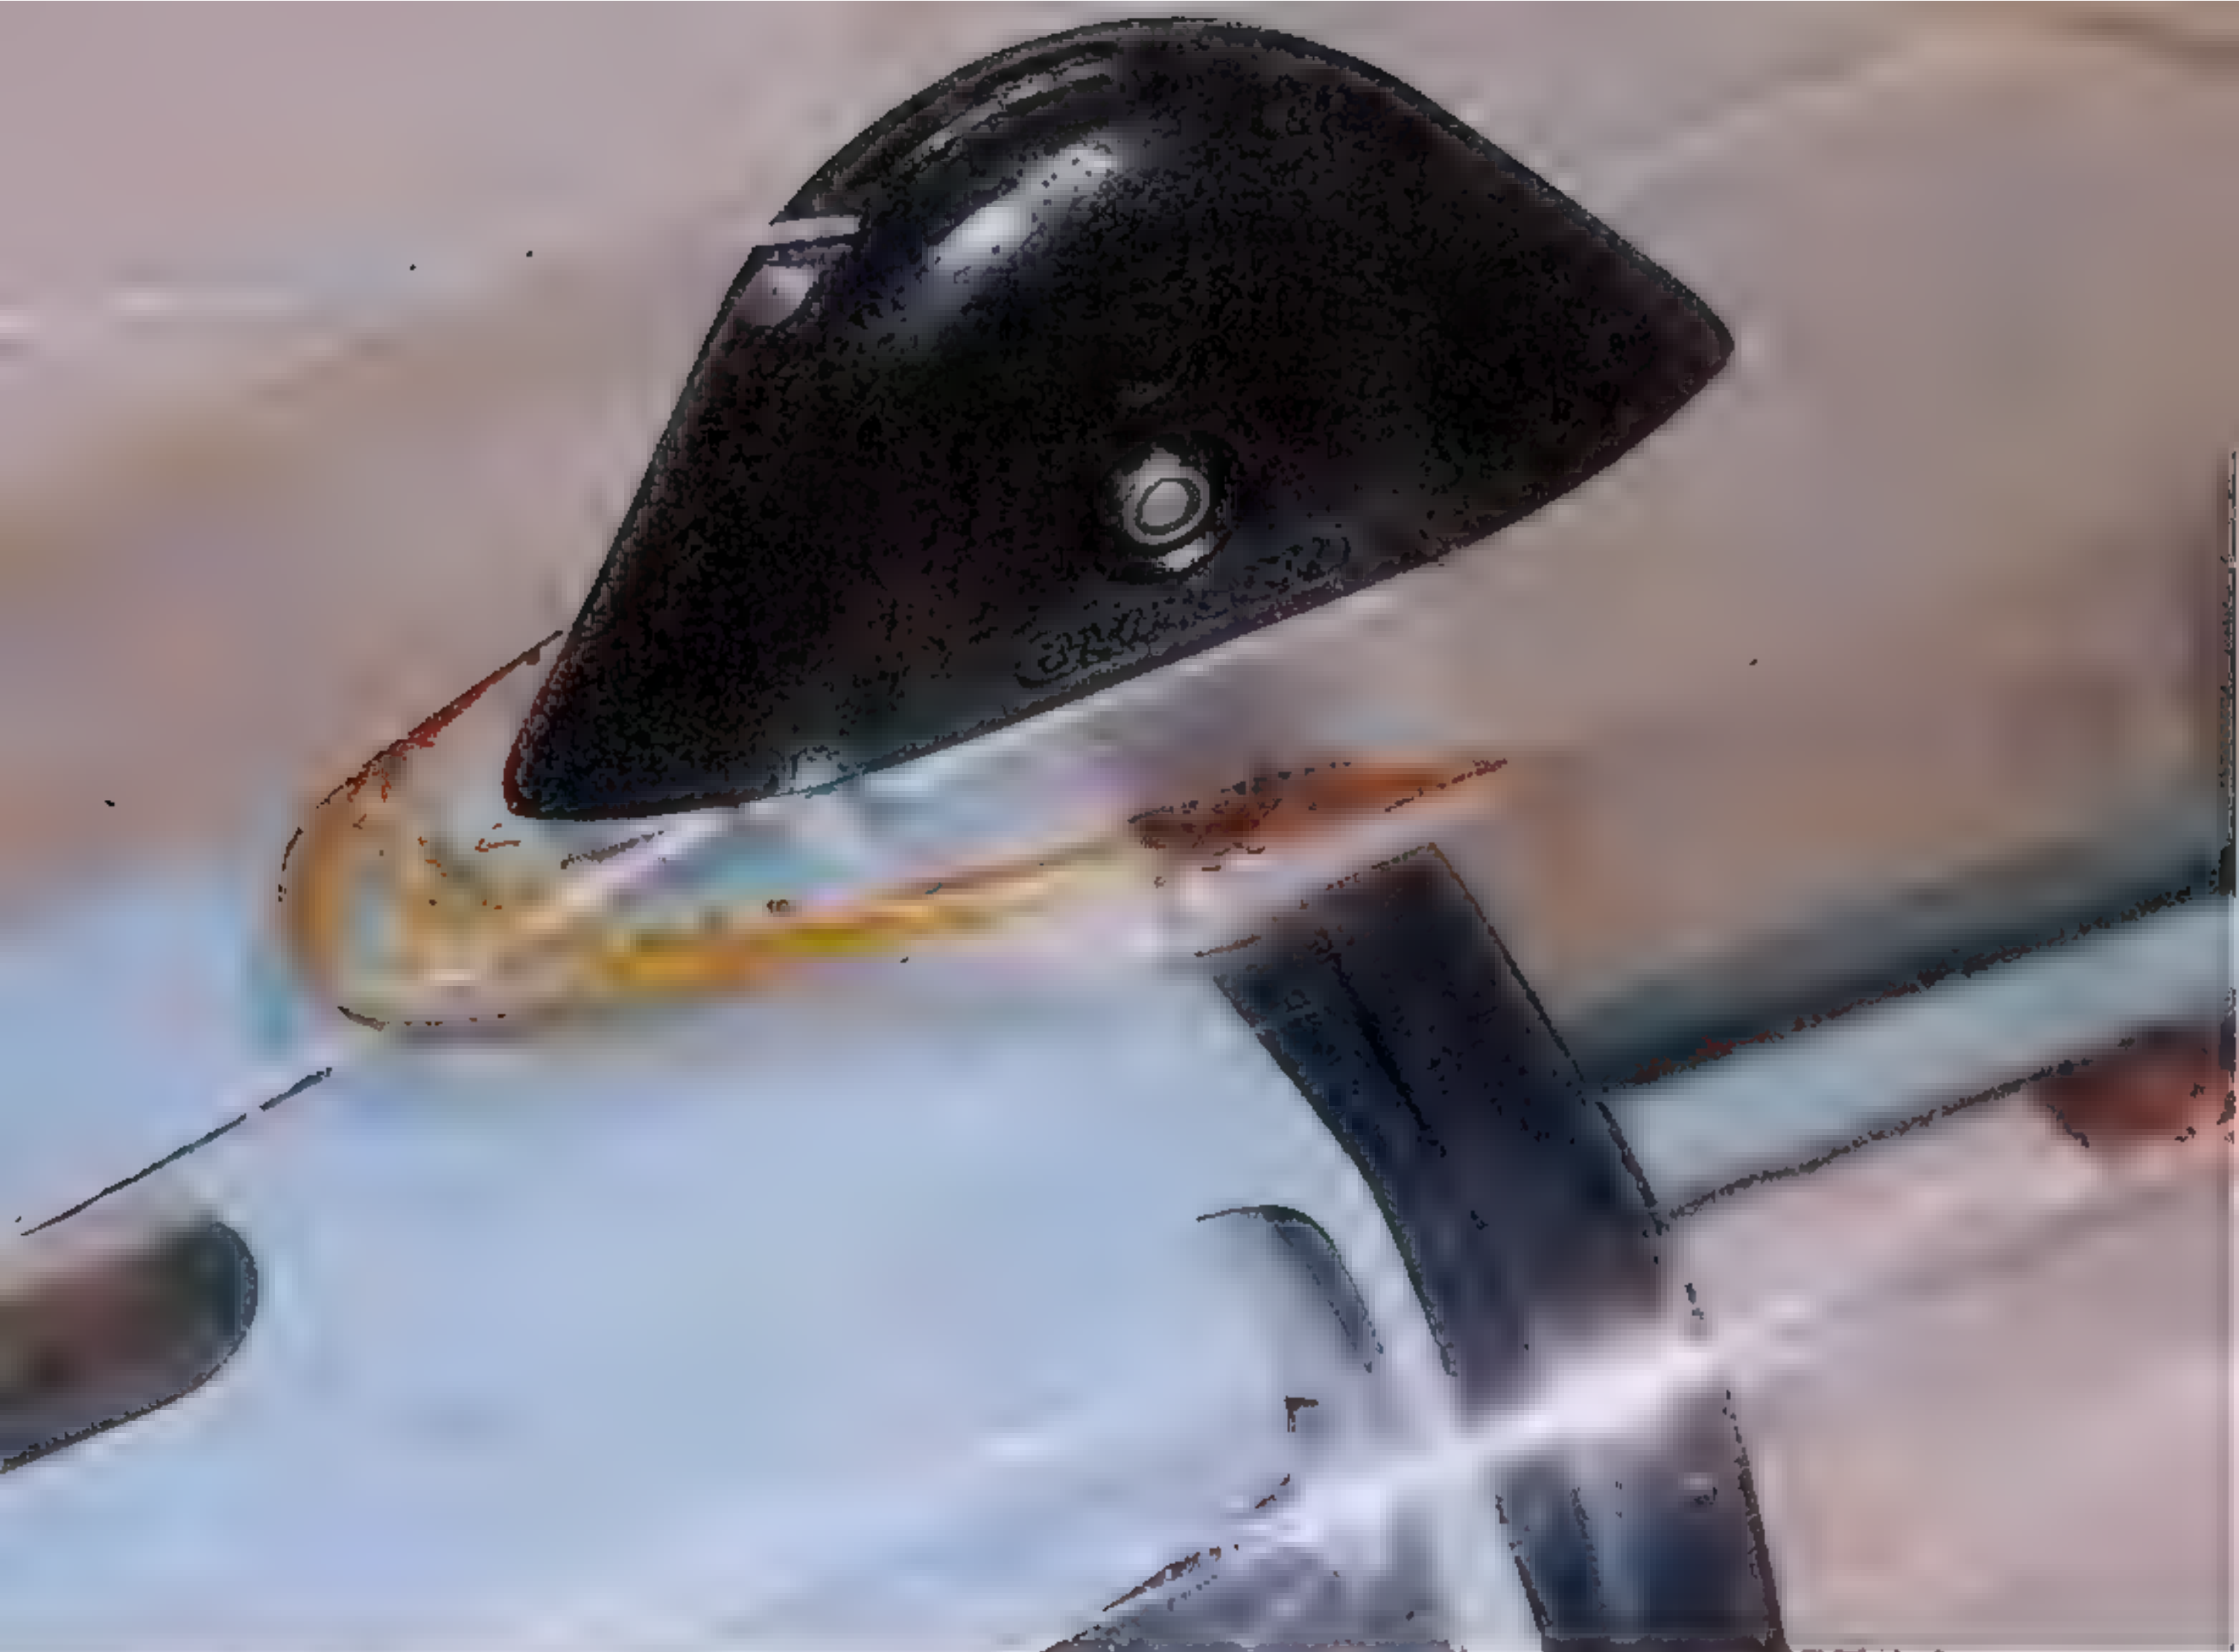
(Above Right) The antenna wire roller assembly is attached to the Fw 190A's canopy by two bolts – one forward and one aft of the roller. A second piece of Plexiglas was glued onto the inner surface of the canopy where the roller assembly was placed. This added section was standard on all 'flat' Fw 190A canopies and helped provide strength and rigidity to the assembly. The antenna wire ran from the roller assembly through a slot in the metal section connected to the armored headrest into the fuselage. (Thinnes)
